REPAIR, EVALUATION, MAINTENANCE, AND
REHABILITATION RESEARCH PROGRAM

TECHNICAL REPORT REMR-CO-5

STABILITY OF DOLOS OVERLAYS FOR
REHABILITATION OF DOLOS-ARMORED
RUBBLE-MOUND BREAKWATER AND JETTY
TRUNKS SUBJECTED TO BREAKING WAVES

Coastal Engineering Research Center

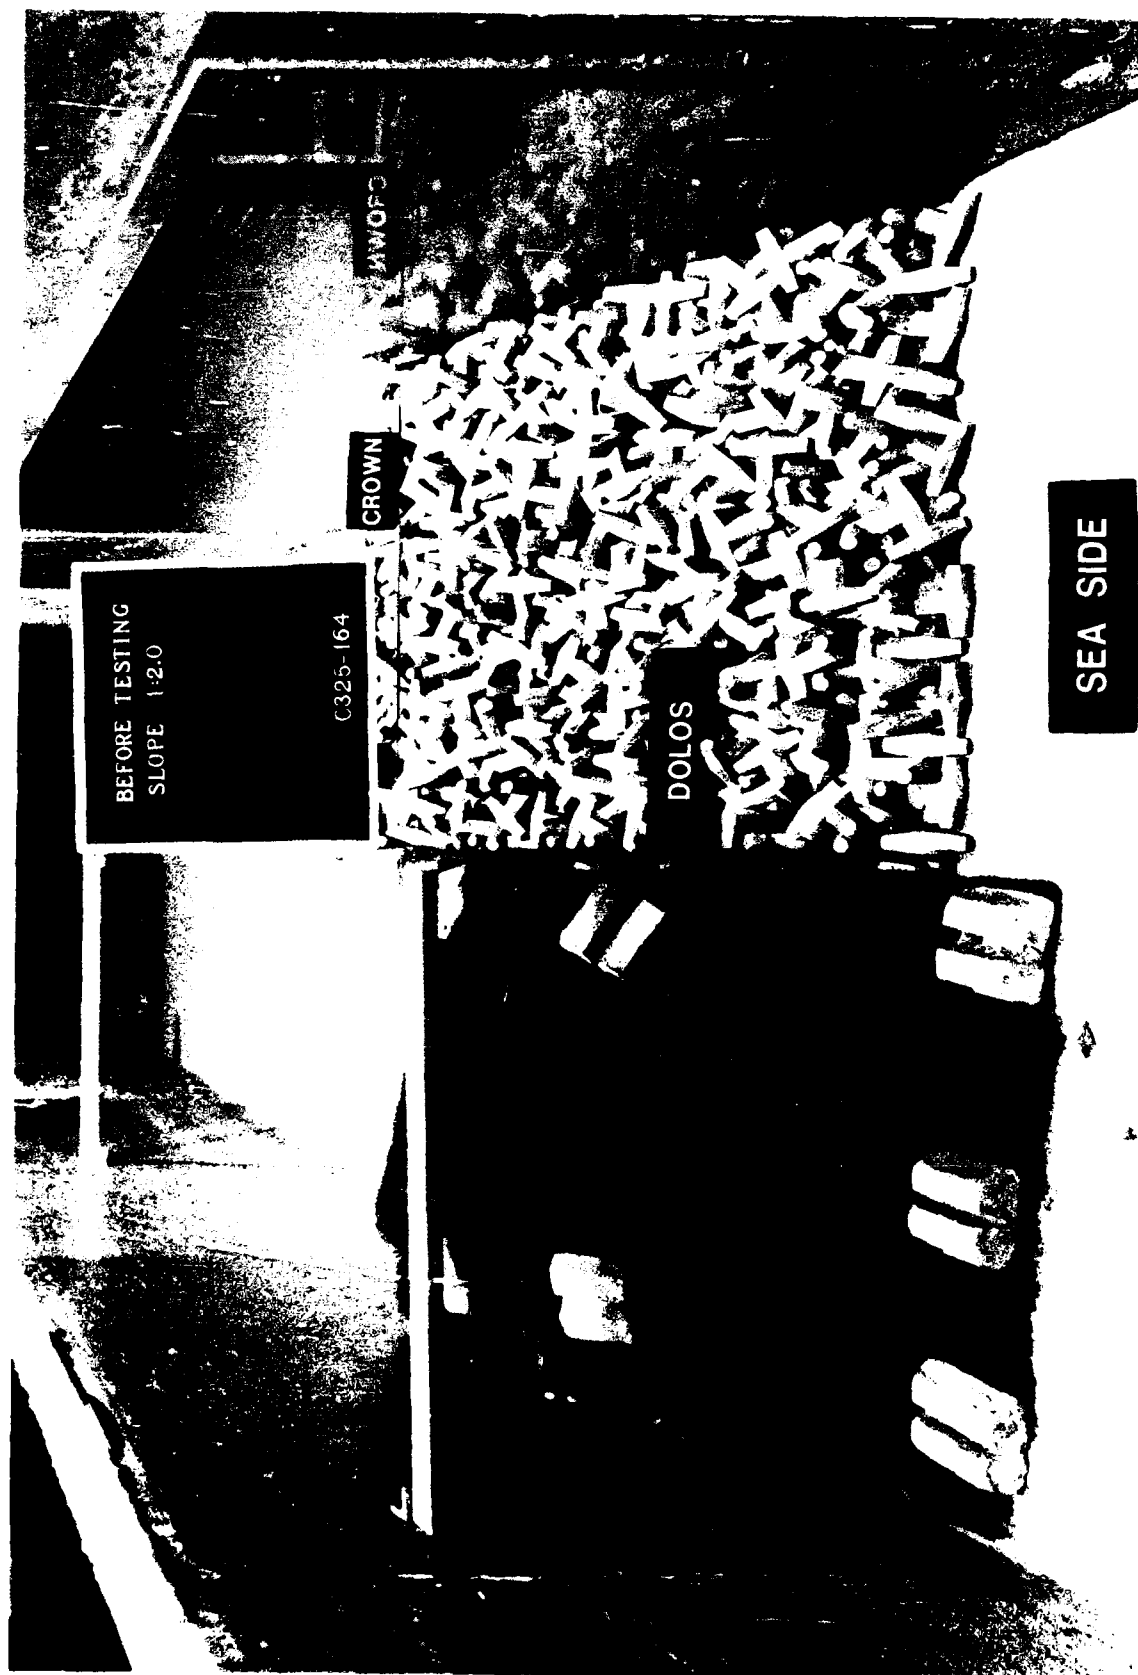
Photo 4. Sea-side view of a typical test section before wave attack at a
IV-on-2H-sea-side-structure slope; $W_a = 0.442$ lb

17. All stability tests were conducted on sections of the type shown in Figure 1 and Photos 1-4. Sea-side slopes of 1V on 1.5H and 1V on 2H were investigated, while the beach-side slope was held constant at 1V on 1.5H. Heights of the simulated existing structures (prior to placement of the dolos overlays) varied from 1.0 to 1.2 ft. The height necessary to prevent wave overtopping of the existing structure was determined from slopes and estimated water depths and wave heights to be investigated in determining stability coefficients for the dissimilar armor overlays.

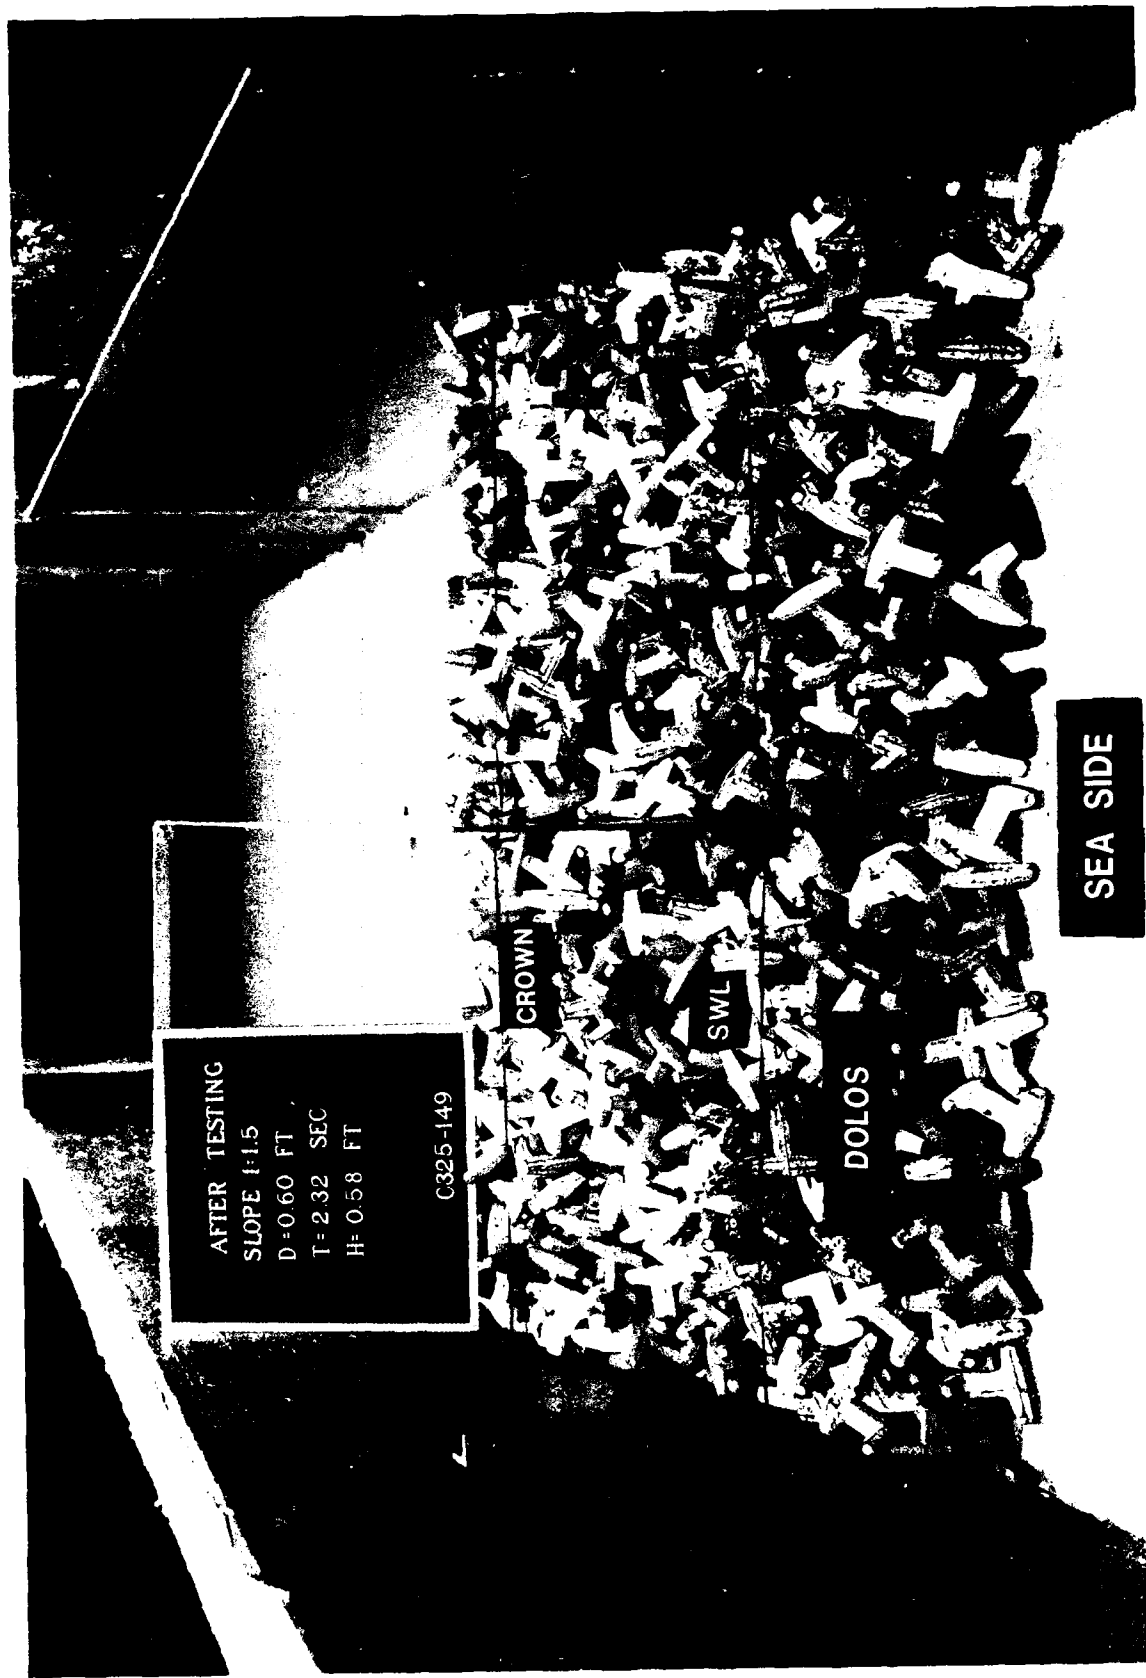
Photo 7. Sea-side view after attack of 2.32-sec, 0.58-ft waves; $d = 0.60$ ft;
 $W_a = 0.589$ lb; 1V-on-1.5H-structure slope

Photos 5-20 show typical after-testing conditions of the structures.
